STARLIGHT LAKE DAM

NDI ID NO. PA-00094
DER ID NO. 64-35

PHASE I INSPECTION REPORT
NATIONAL DAM INSPECTION PROGRAM

MAY 1981

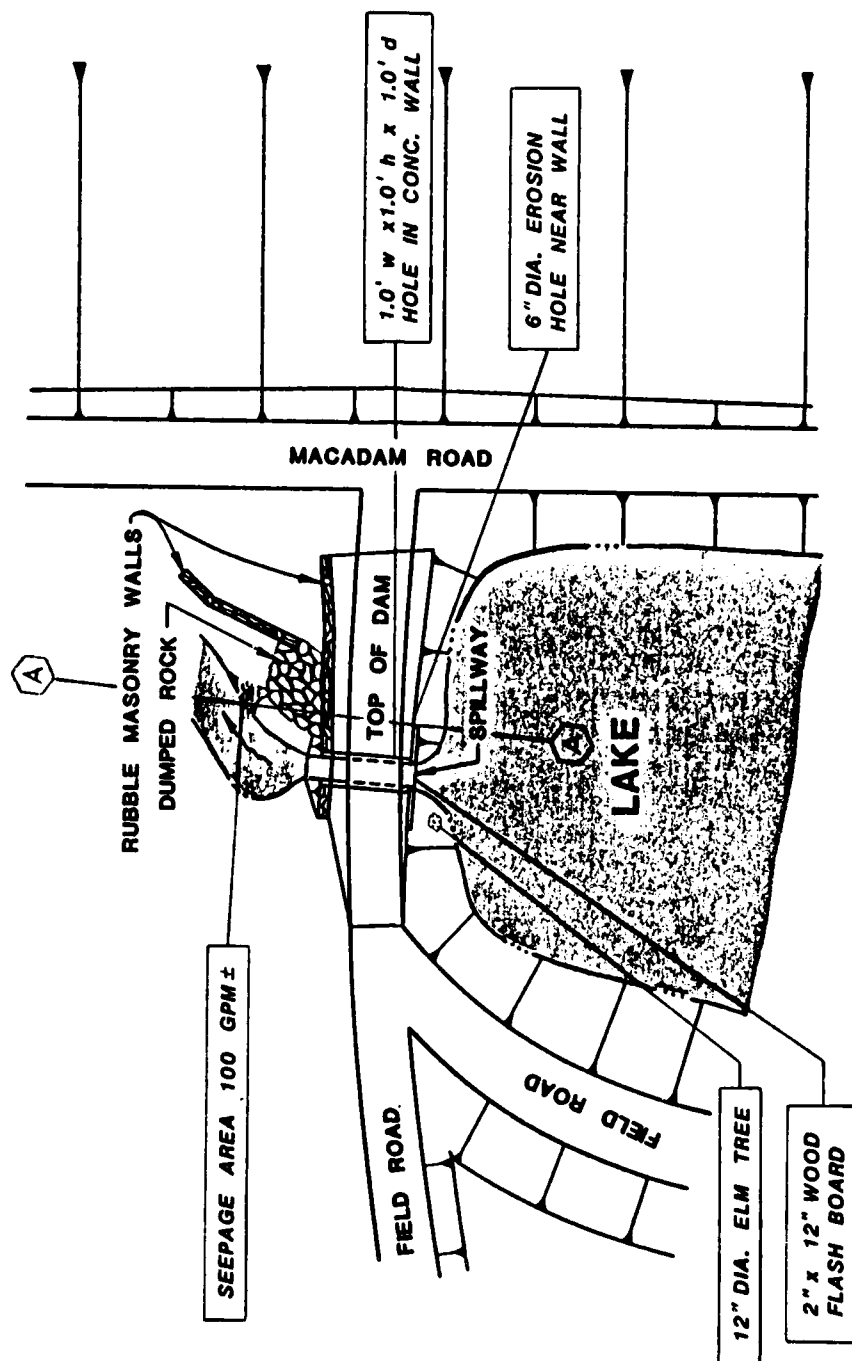
STARLIGHT LAKE DAM GENERAL PLAN - FIELD INSPECTION NOTES

a. General. The overall appearance of the dam is poor. Locations of observed deficiencies are shown on the General Plan, presented in Exhibit A-1, Appendix A. The profile and typical sections of the dam are presented in Exhibits A-2 and A-3 and are based on field survey made on the days of inspection. The survey datum for this inspection is elevation 1355 feet above mean sea level for the normal water surface of the lake at the top of the spillway flashboard (see Exhibit E-1). On the inspection date (12/11/1980), the lake level was approximately at elevation 1355.5, or 0.5 foot above the spillway flashboard. Deficiencies observed during the field inspection are described below, and further illustrated in Exhibit A-1, Appendix A. Visible features are depicted in photographs, presented in Appendix E.

b. Dam. Observations made during inspection indicate that the dam is in poor condition. The upstream slope varies from 1V on 6.7H to 1V on 10H (see Exhibit A-3). In the vicinity of the spillway along a distance of 22 feet, there is an upstream vertical masonry wall (see Exhibit A-3). The top width of the dam varies from 12 feet at the left abutment to 25 feet at the right abutment. The lowest top of dam elevation is 1357.5, near the right abutment (see top of dam profile presented in Exhibit A-2). A 6-inch diameter erosion hole is located on the upstream side of the dam near the right end of the spillway headwall. A 12-inch diameter elm tree is located upstream of the dam, approximately at elevation 1356.8 near the termination of the spillway left headwall (see photographs 1 and 2, Appendix C). The downstream face of the dam includes a 58 foot long dry masonry wall with a slope of 4V on 1H (see photographs 3, 4 and 5, Appendix C). Dumped rock on the downstream face of the dam extends about 20 feet beyond the right end of the spillway culvert outlet and terminates at a dry stone wall on the right abutment. This wall begins at the downstream face of the dam and extends downstream for an approximate distance of 30 feet (see Exhibit A-1). The location and extent of the dumped rock and the downstream dry stone masonry wall is also shown in photograph 3, Appendix C. On the inspection dates, leakage emanating from the toe of the dumped rock was clear and its flow was estimated to be about 100 GPM. The location of the observed leakage is shown in Exhibit A-1.

ITEM	OBSERVATIONS/REMARKS/RECOMMENDATIONS	NDI# PA - 094
SURFACE CRACKS	No cracks. However, a 6" diameter erosion hole is located on right end of upstream wall.	
UNUSUAL MOVEMENT OR CRACKING AT OR BEYOND THE TOE	None	
SLOUGHING OR EROSION OF EMBANKMENT AND ABUTMENT SLOPES	None	
VERTICAL AND HORIZONTAL ALIGNMENT OF THE CREST	For vertical alignment, see Exhibit A-2. Slightly curved horizontal alignment on left abutment (see Exhibit A-1).	
RIPRAP FAILURES	None. However, dumped stone was placed against right stone wall on downstream side. No riprap on upstream face.	
JUNCTION OF EMBANKMENT AND ABUTMENT, SPILLWAY AND DAM	Good transition between top of dam and the abutments on both upstream and downstream ends. Vertical spillway sluiceway walls about the composite dam section at center of dam.

ITEM	OBSERVATIONS/REMARKS/RECOMMENDATIONS	NDI# PA - 094
DAMP AREAS IRREGULAR VEGETA- TION (LUSH OR DEAD PLANTS)	None	
ANY NOTICEABLE SEEPAGE	About 100 GPM leakage area at tow of dumped rock. This is directly downstream of erosion hole observed on right end of upstream wall.	
STAFF GAGE AND RECORDER	None	
DRAINS	None	
ROCK OUTCROPS	None in vicinity of dam.	
DAM FOUNDATION TREES, OTHER	Some small brush near right downstream stone wall. A 12" diameter Elm tree, on upstream face of dam and left of spillway. No visible undermining at the toe of dam.

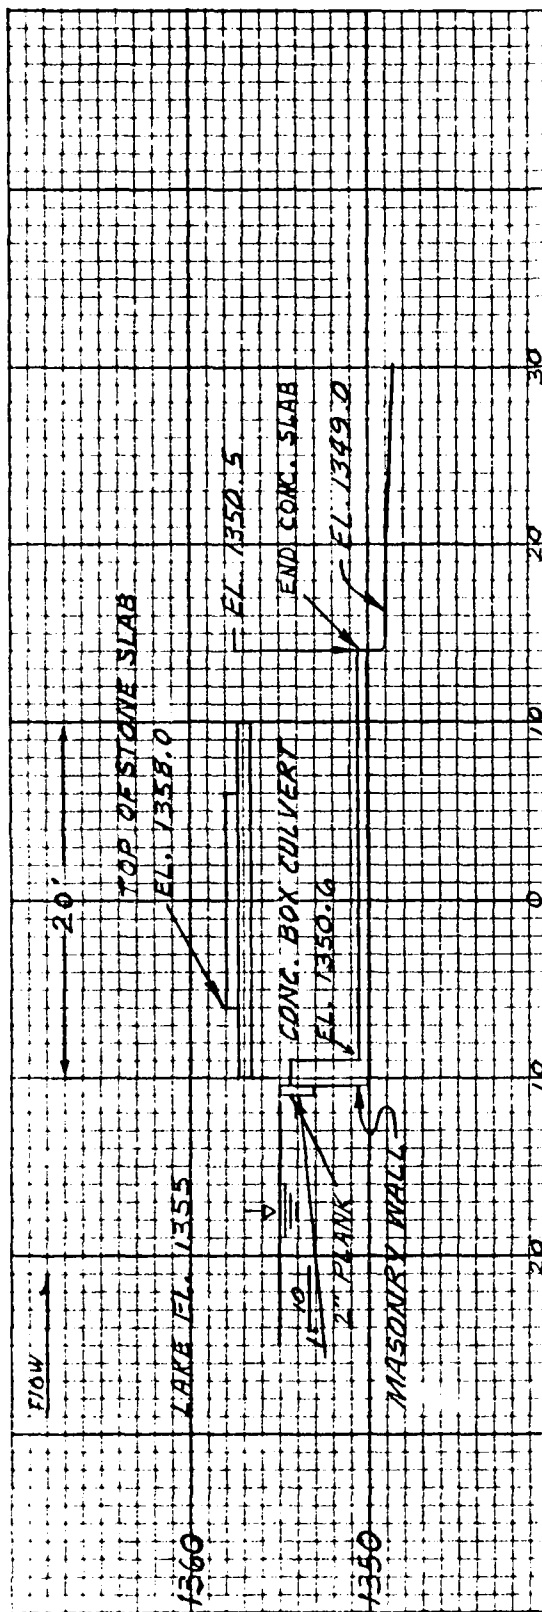
SPILLWAY SECTION

c. Spillway. The overall appearance of the spillway is fair. Flow over the flashboard drops 4.4 feet to the floor of a rectangular concrete culvert. A large hole 1.0'H x 1.5'L x 1.0'D located near the upstream end of the right concrete wall of the spillway culvert appears to be due to spalling of the concrete (see Exhibits A-1 and A-4). The span between the top of the culvert walls is covered with 6-inch sandstone rock slabs. Additional slabs, varying in thickness from 9 to 11 inches, overlay the first layer of slabs to form the road surfaces on the top of the dam (see Exhibit A-3 and photograph No. 6, Appendix C). Concrete ledges at the

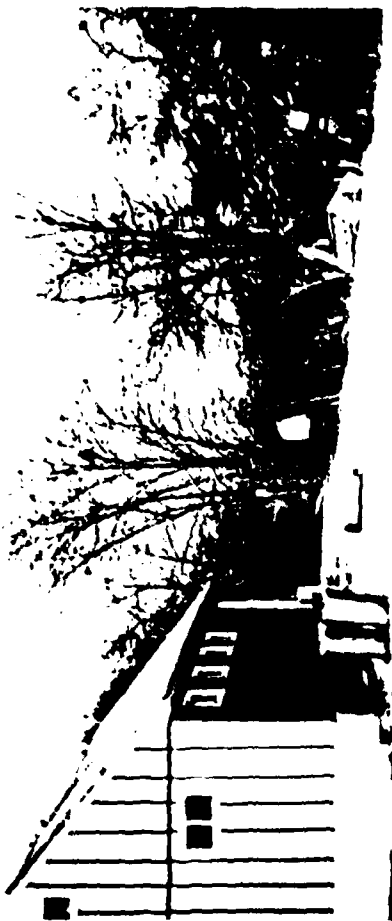
9 600' DOWNSTREAM OF DAM (STREAM AT EDGE OF SNOW)

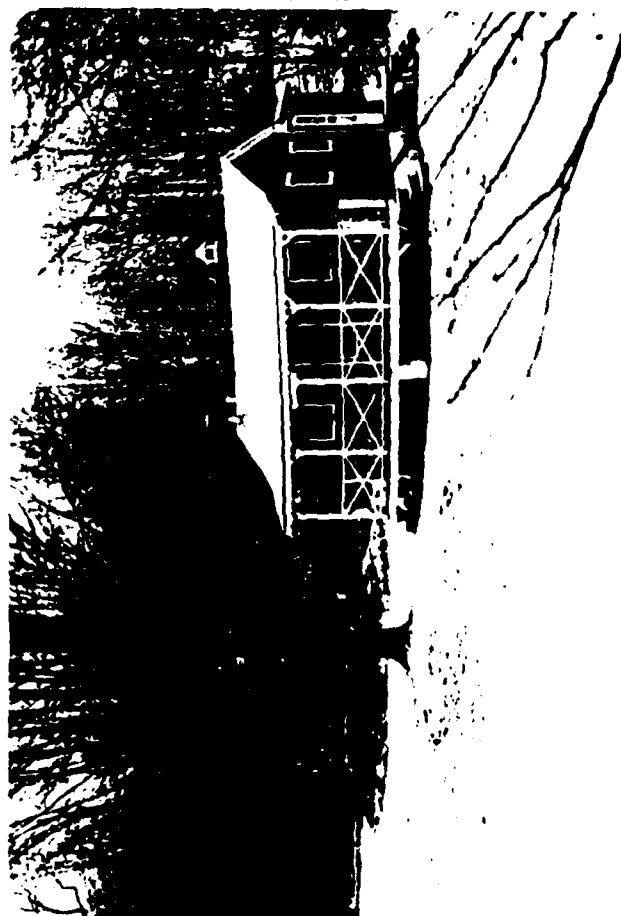
10 STREAM AT REAR OF HOUSE

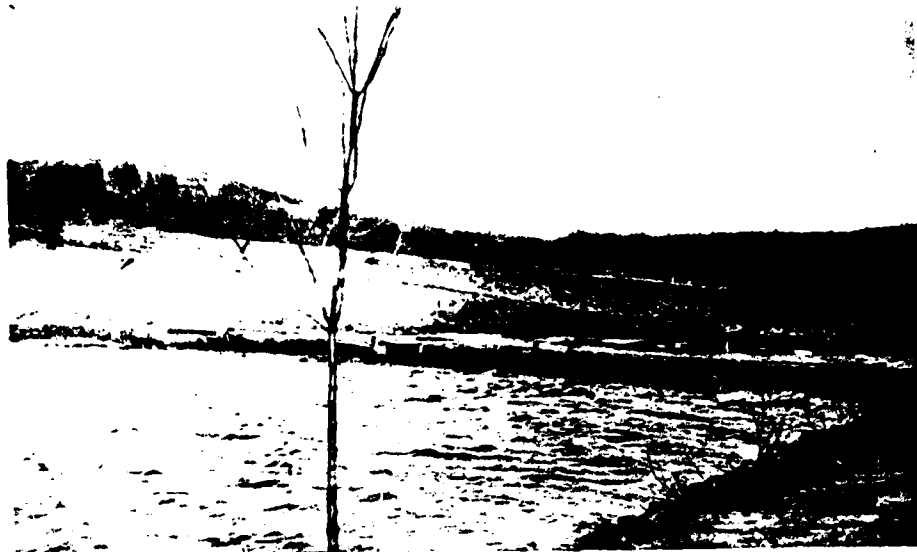
UPSTREAM FACE OF DAM (LAKE IN FOREGROUND, FARMLAND IN BACKGROUND, DOWNSTREAM OF DAM)
SHOWING NEW SHEETING OVER CINDER CONCRETE WALL

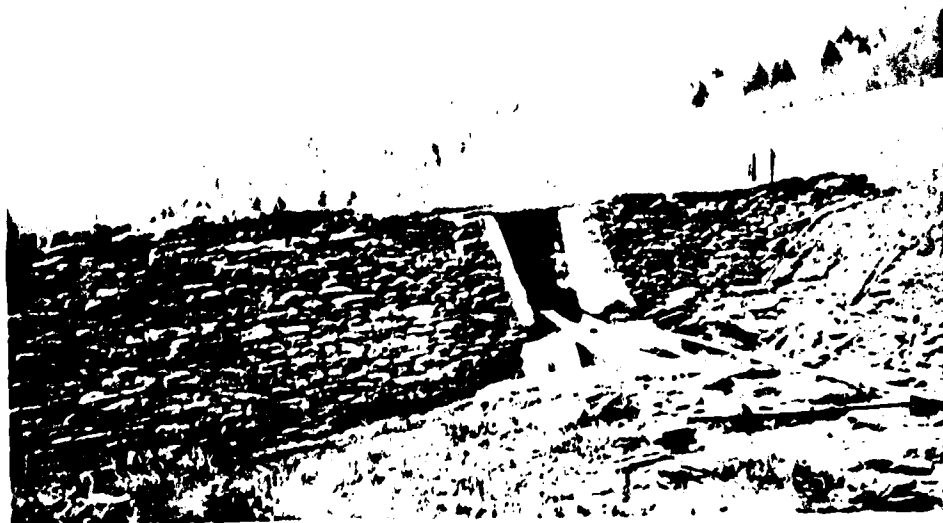
DOWNSTREAM FACE OF DAM AND SLUICEWAY

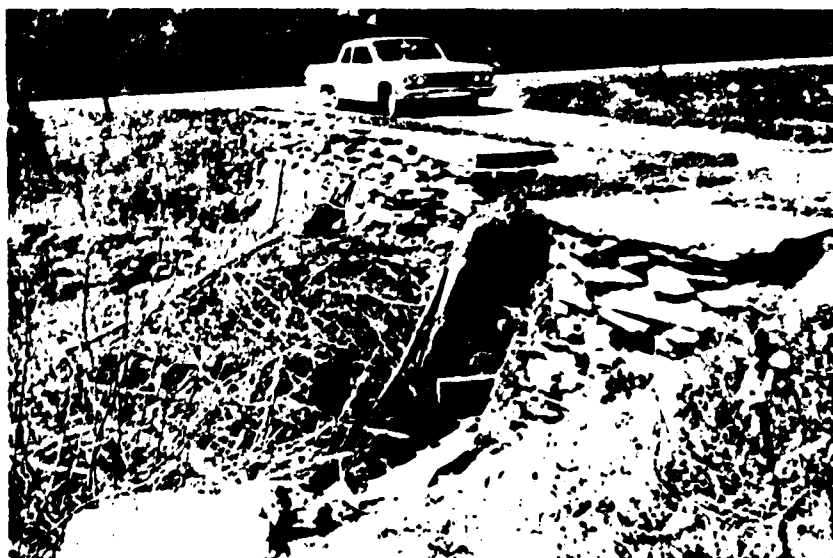
DOWNSTREAM FACE OF DAM AND SLUCEWAY
